**EKSPERIMENTALNE IN NUMERIČNE PREISKAVE ZA
DOLOČITEV KONTROLIRANEGA ODZIVA
VEČSLOJNE KAMNITE ZIDOVINE**

Doktorska disertacija štev.: 247

**PERFORMANCE BASED EXPERIMENTAL AND
NUMERICAL ASSESSMENT OF MULTI-LEAF STONE
MASONRY WALLS**

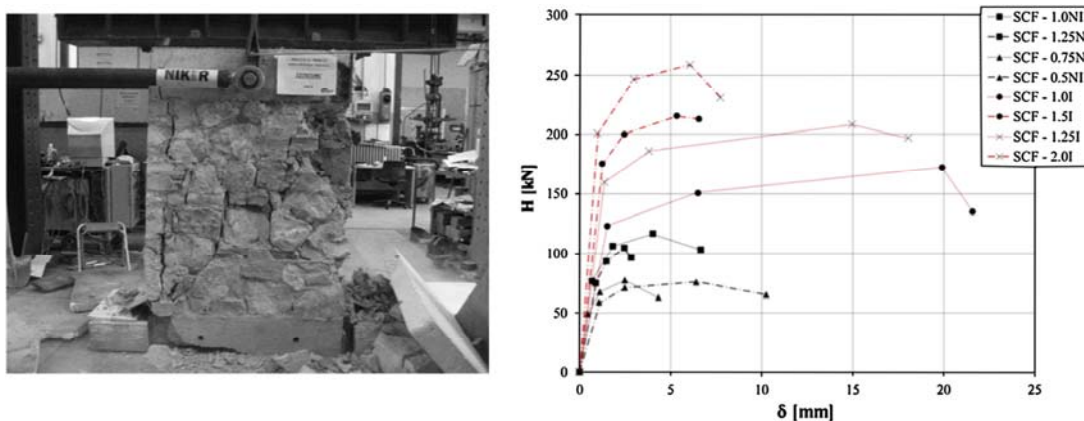
Figure 2.22: Silva et al [6]: crack pattern of the full scale un-grouted wall after shear test (left), comparison of the obtained results for full scale walls (right)

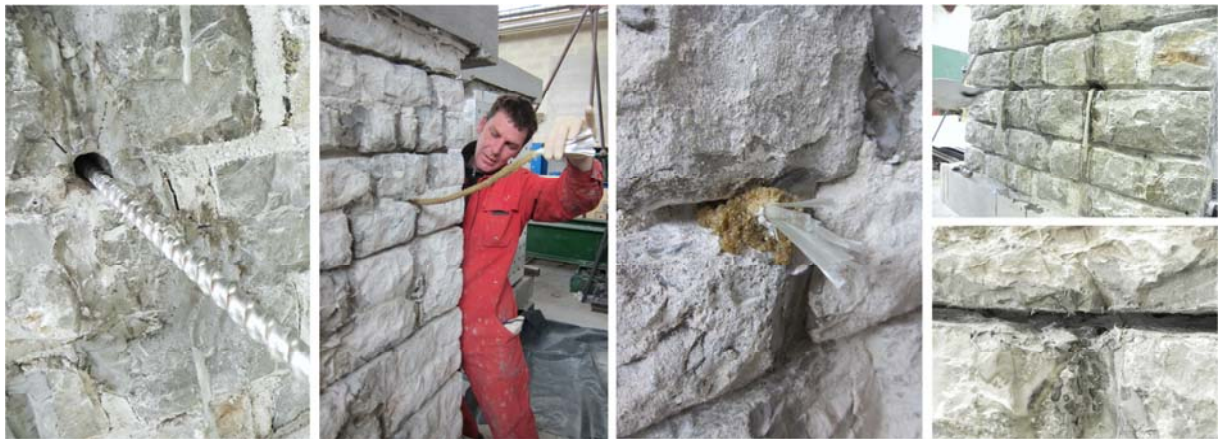
Figure 4.18: Drilling of the hole, the insertion of the impregnated cord coated in sand and sand "plug", transversal connection with impregnated cord (upper right) and with spread and fixed fibres (test 8 only, bottom right)
Slika 4.18: Vrtanje luknje, povezovanje slojev zidu z impregnirano in s peskom posuto vrstico, pečeni "čep", prečna povezava z impregnirano vrstico (zgoraj desno) in razprostrta in prilepljena vlakna (samo test 8, spodaj desno)

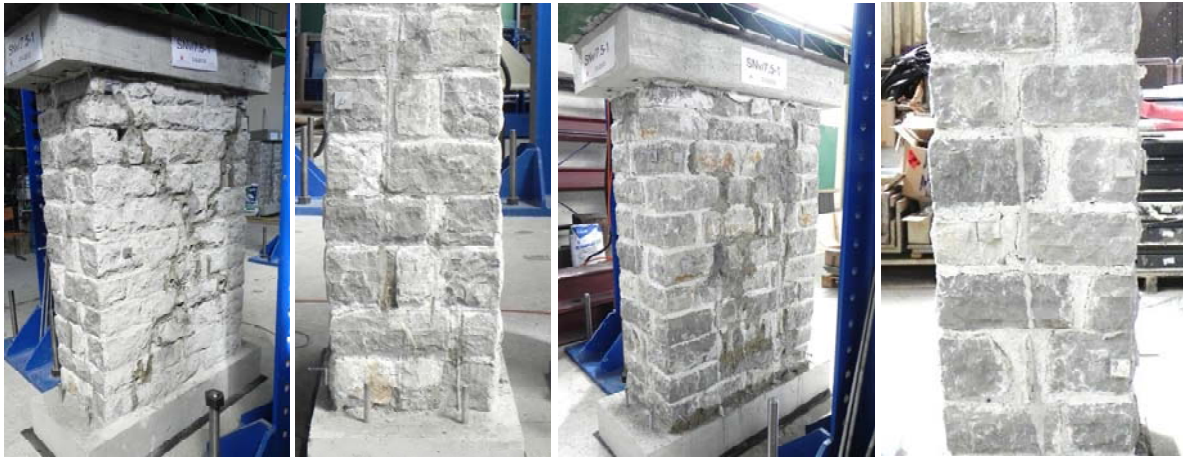
Figure 5.1: Grouted wall with existing damage pattern prior testing (test T1 - I(n))
Slika 5.1: Injektirani zid z obstoječimi razpokami pred testiranjem (test T1 - I(n))

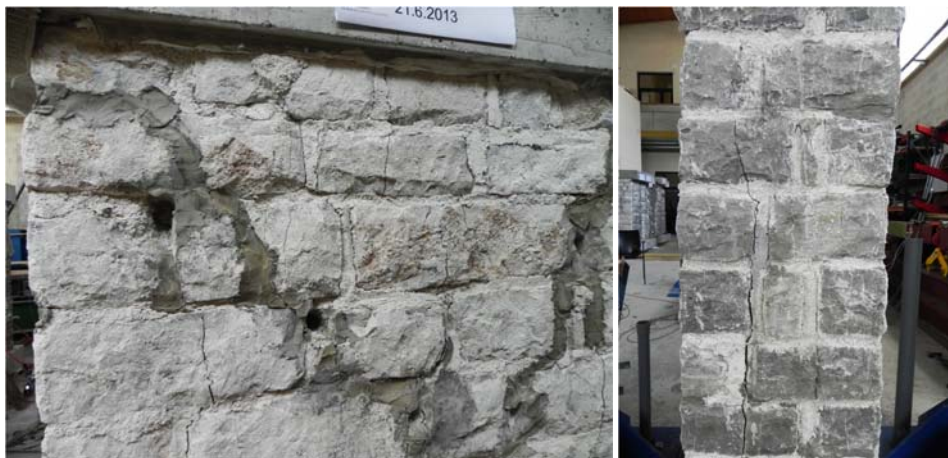
Figure 5.2: Damage pattern after failure attained at test T1 - I(n)
Slika 5.2: Poškodovanost zidu po testu T1 - I(n)

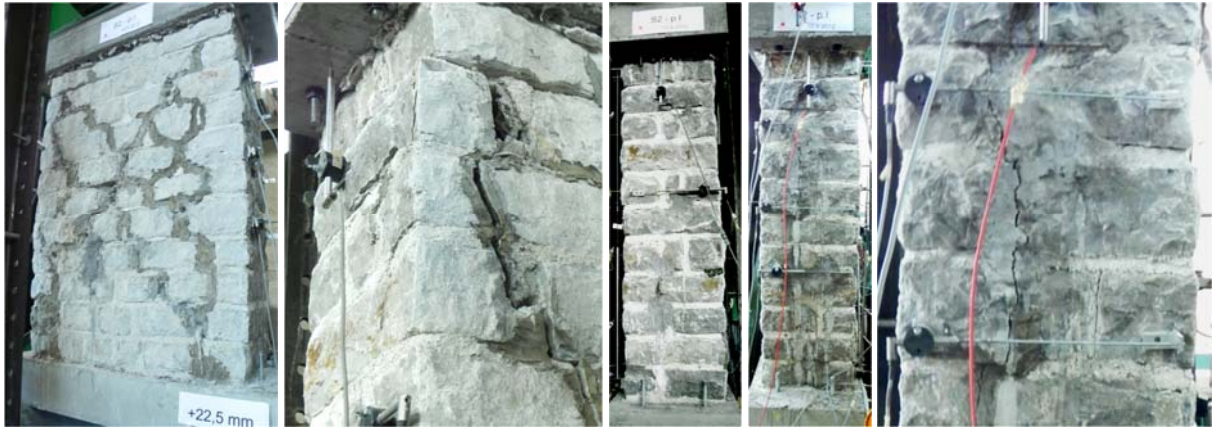
Figure 5.13: Damage after test S2 – I(p) on the front and transversal sides of the wall
Slika 5.13: Razpokanost zidu na prednji in stranskih straneh zidu po testu S2 – I (p)

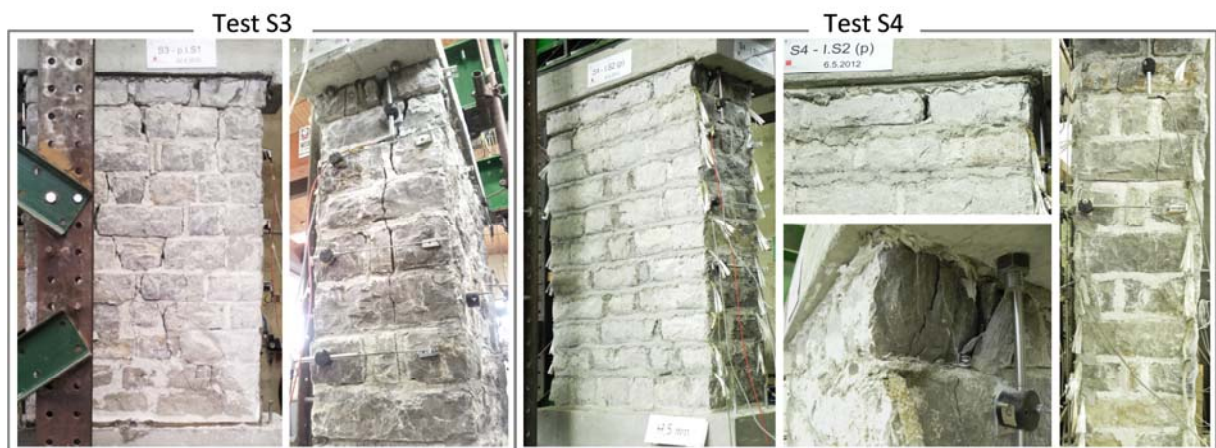
Figure 5.14: Rocking and minor shear damage on the wall after test S3 – I.S1(p) and rocking and toe crushing at test S4 - I.S2(p)

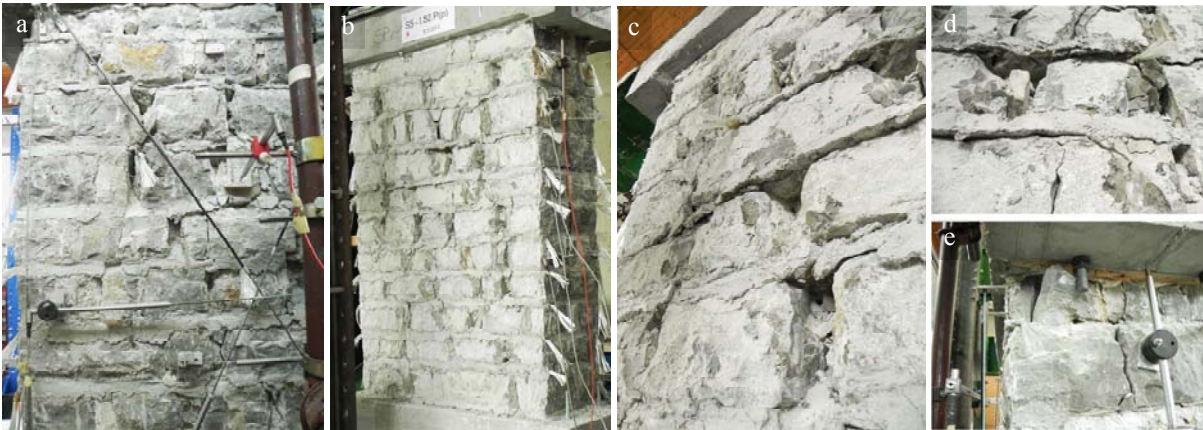
Figure 5.15: Crack pattern on the wall (a, b) with cord detachment (c, d) and toe crushing (e) after test S5 - I.S2.P(p)
Slika 5.15: Razpokanost zidu (a, b) z odstopanjem vrvice (c, d) in zdrobljeno peto (e) po testu S5 - I.S2.P(p)

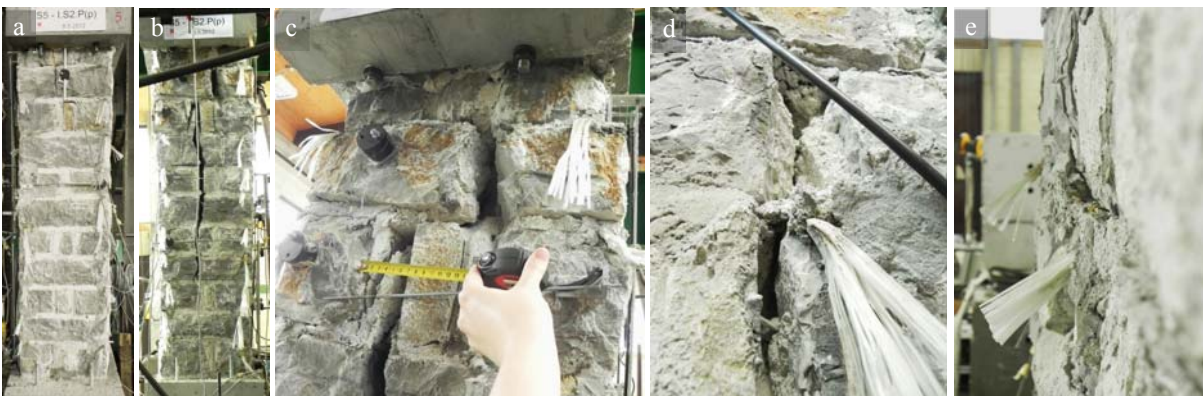
Figure 5.16: Leaf separation with toe-crushing (a-c), damage of the transversal connections (d, e) of the wall after test S5 - I.S2.P(p)
Slika 5.16: Razpoka (vrzel) med slojema ter zdrobljena peta (a-c), poškodovanost prečnih povezav (d, e) zidu po testu S5 - I.S2.P(p)
