Stepwise mitigation of the Macesnik landslide, N Slovenia

M. Mikoš¹, R. Fazarinc², B. Pulko¹, A. Petkovšek¹, and B. Majes¹

Abstract. The paper gives an overview of the history of evolution and mitigation of the Macesnik landslide in N Slovenia. It was triggered in 1989 above the Solčava village, but it enlarged with time. In 2005, the landslide has been threatening a few residential and farm houses, as well as the panoramic road, and it is only 1000 m away from the Savinja River and the village of Solčava. It is 2500 m long and up to more than 100 m wide with an estimated volume in excess of 2 million m³. Its depth is not constant: on average it is 10 to 15 m deep, but in the area of the toe, which is retained by a rock outcrop, it reaches the depth of 30 m. The unstable mass consists of water-saturated highly-weathered carboniferous formations. The presently active landslide lies within the fossil landslide which is up to 350 m wide and 50 m deep with the total volume estimated at 8 to 10 million m³. Since 2000, the landslide has been investigated by 36 boreholes, and 28 of them were equipped with inclinometer casings, which also serve as piezometers. Surface movements have been

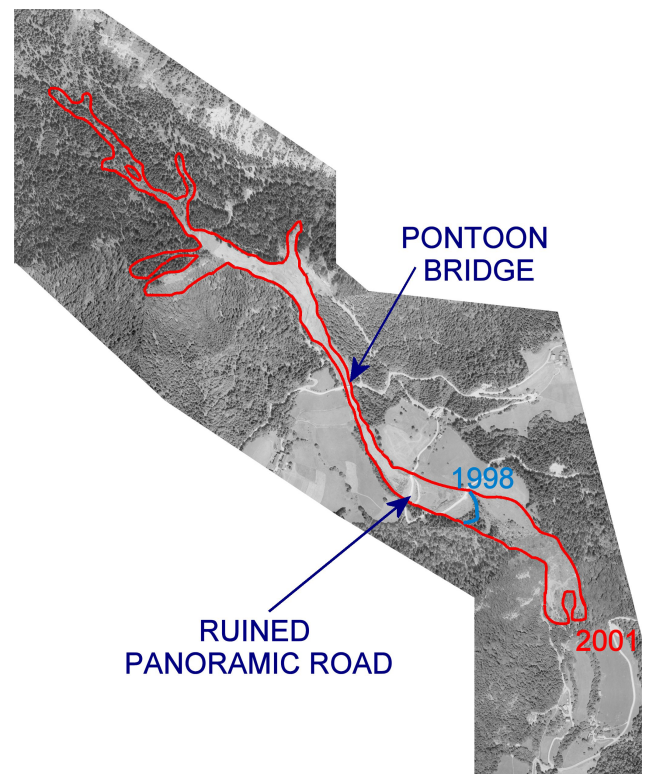
Fig. 2. Aerial view of the contours of the Macesnik landslide in 1998 and 2001.

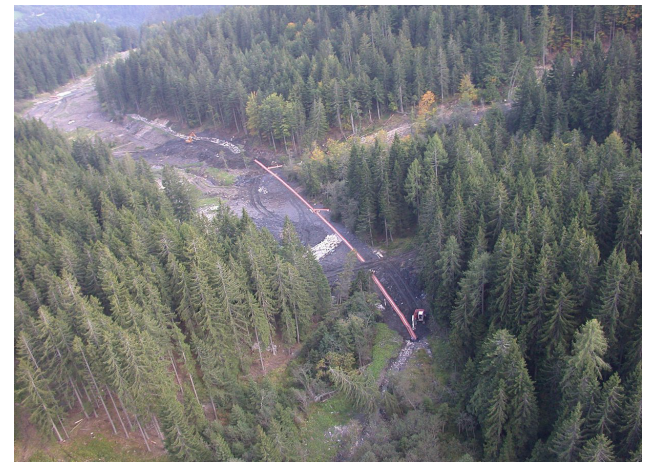
Fig. 10. Executed peripheral surface drainage at the western landslide edge above the prefabricated bridge.

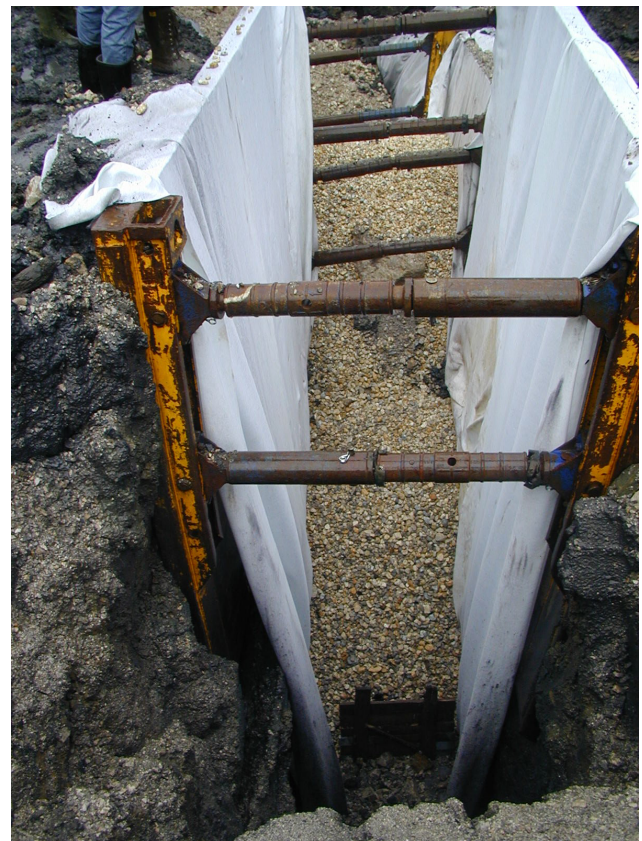
Fig. 13. Detail of deep drain trenches.

In summer 2003, above the pontoon bridge, subsurface drainage works in the form of 3 parallel deep drainage trenches filled with gravels (Figs. 12 and 13) were constructed to collect ground water and decrease the ground water table. The main aim was to slow down the landslide displacements in the area and to make possible the execution of planned restraint constructions above the pontoon bridge. In spring 2004, in the upper part of the landslide two additional deep drainage trenches were constructed (Fig. 14).

The deep drainage trenches were excavated to a depth of ~8 m, that is, to the impermeable rock layer. First, longitudinal trenches 3 m deep and 5 m wide at the bottom were dug with the slope of 1:1. Part of the removed material was transported to a dumping site, and part of it was stored close to the construction site and later used for the levelling of the landslide surface (Fig. 15). The digging of the trenches to the final depth of 8 m was executed in 6 m long sections. The vertical excavation was protected using 1-m wide hydraulic panning. The drainage was executed using PEHD pipes

DN 400, filled with a gravel filter of 32–64 mm. The filter material together with the pipe was wrapped into a filter geotextile with a minimum tensile strength of 20 kN/m and with pores <0.15 mm. Near to the local springs, additional transversal drainage ribs were introduced. The measured average amount of drained water from the completed drainage trenches was between 1.5 and 3 l/min or between 2.16 and 4.32 m³/day.

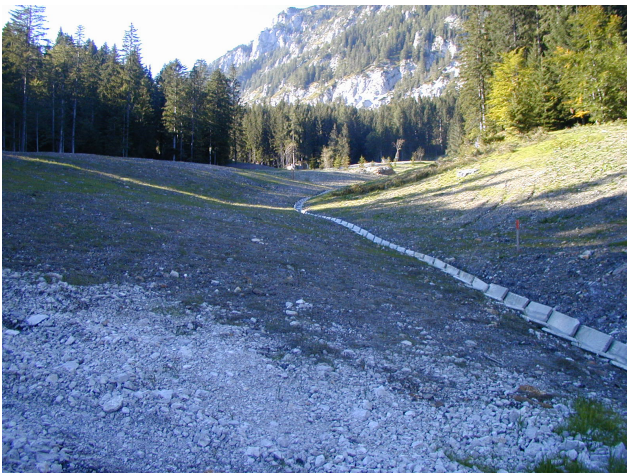
Fig. 15. Stabilised part of the Macesnik landslide above the pontoon bridge by introducing several deep drainages and peripheral and central surface drainage.

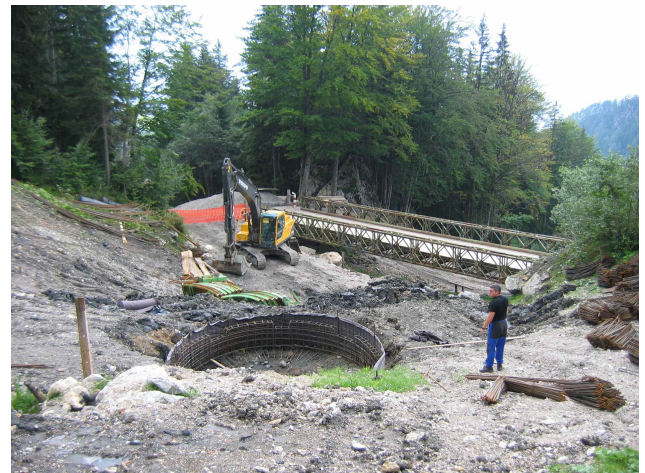
Fig. 16. Execution of a RC well just above the pontoon bridge.

The RC shafts were executed in two phases. First, from the ground surface to a depth of 22 m in steps of 1 m, the primary coating was done. This was separated from the landslide mass by a drainage composite (Enkadrain). The outflow of the drained water from the drainage composite into the shaft was enabled through openings in the primary coating and at every 5 m of the depth to a separate circumferential drainage (Fig. 19). For the drainage PEHD pipes DN 125 were used and reinforced by steel rings. The height of a single ring of the primary coating was 1 m, the thickness of the ring was 30 cm at its top and 20 cm at its bottom, respectively. The dimensions of the rings of the primary coating, the concrete quality and the reinforcement were computed in such a way that the primary coating would take over all the loads from the landslide mass at the computed safety factor $F=1.05$. In the second phase, the 4 m thick concrete foundation plate and the 80 cm thick concrete secondary coating of the shaft were completed.

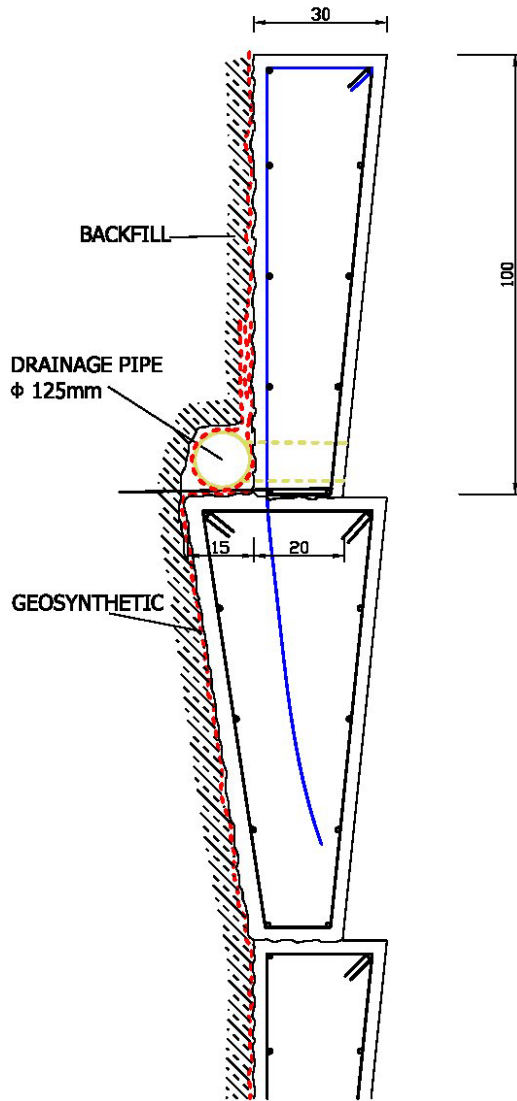
Fig. 19. Detail of the RC well.

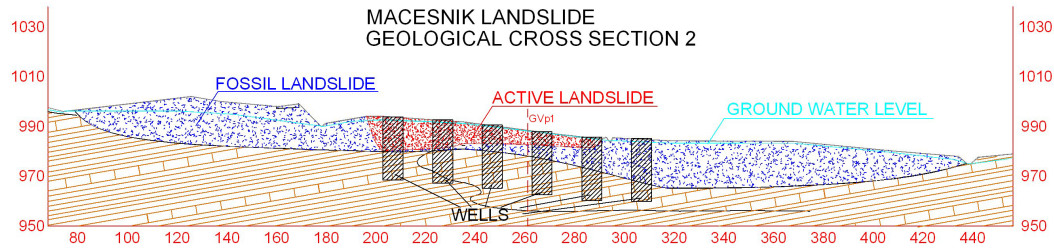
Fig. 22. Cross section of the Macesnik landslide just above the proposed lower line of wells M1–M6.
